CITY OF  
**ORLANDO**

## 2021 ADA TRANSITION PLAN UPDATE

NOVEMBER 30, 2022

Prepared by: Southeastern Surveying & Mapping Corporation

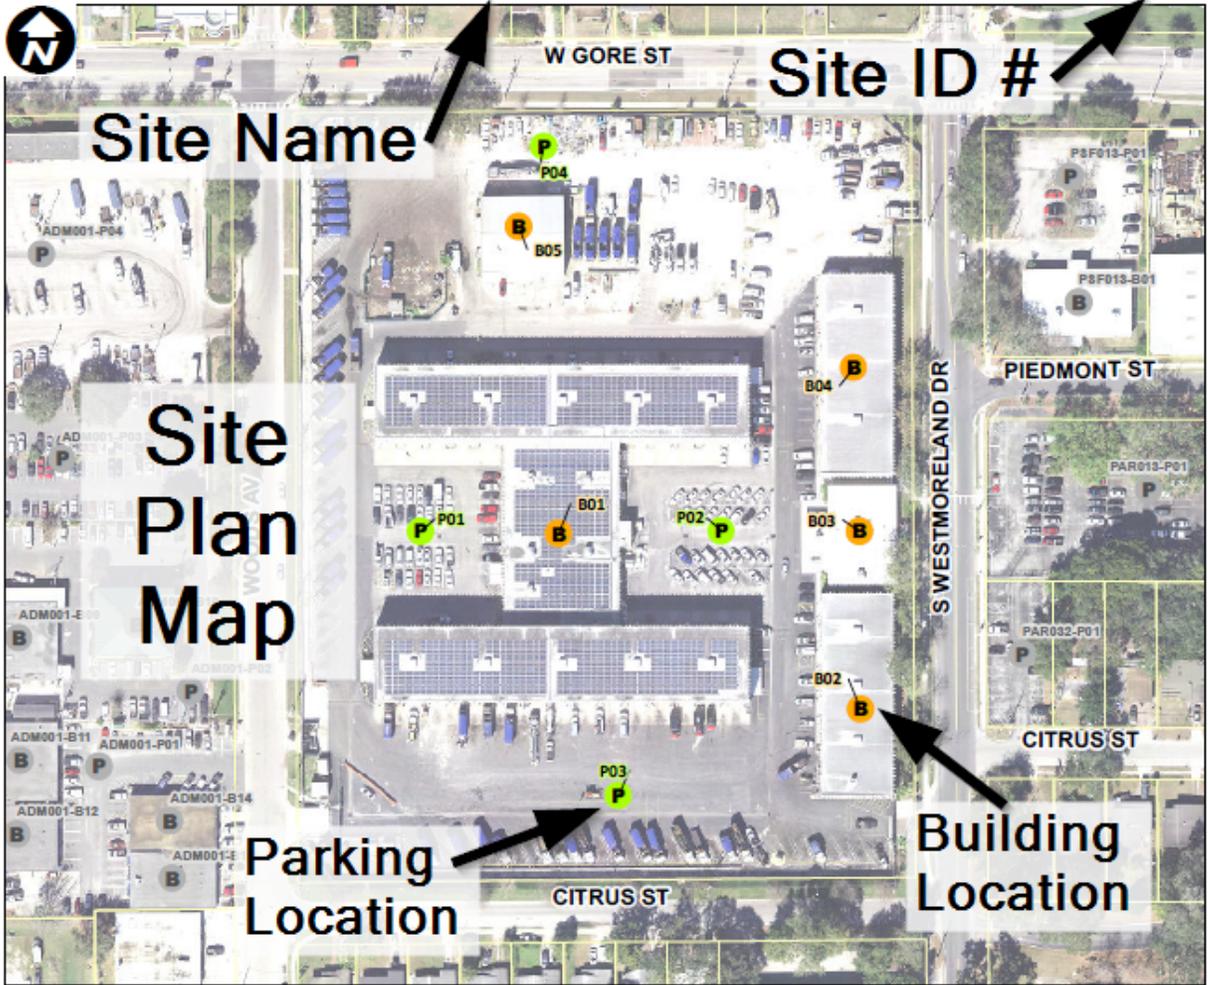
Site Type: Administration  
 Address: 1000 W GORE ST  
 Parcel ID: 342229635500020  
 Site Latitude: 28° 31.801' N  
 Site Longitude: 81° 23.643' W

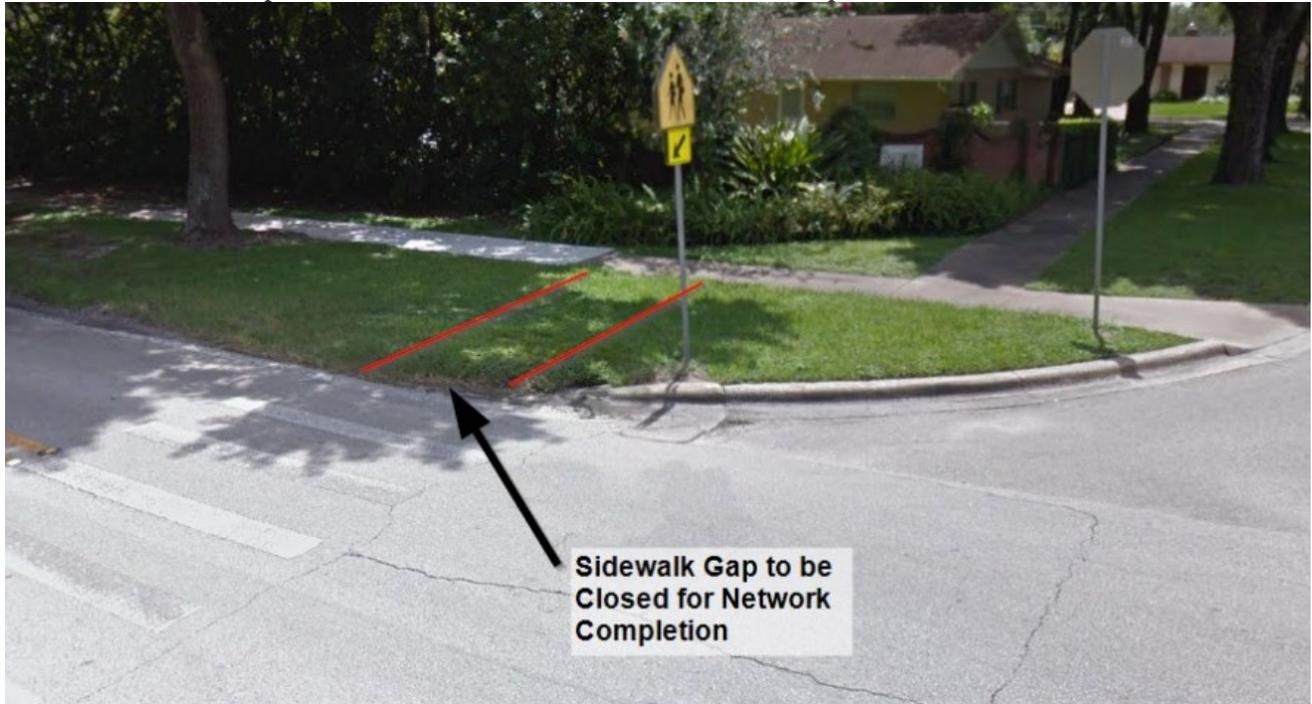
#### 4.1.1 Sidewalk Gaps to be Constructed for Network Completion

Sidewalk gaps are discontinuities in the pedestrian access route where the existing pedestrian access route ends abruptly or does not permit pedestrian access to the roadway as part of a pedestrian street crossing.

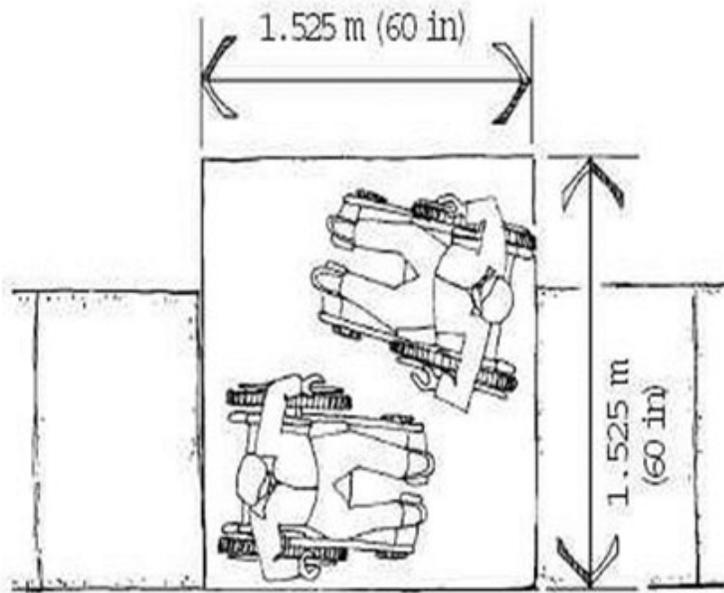
Areas with adequate passing space are those with an area that provides pedestrians in wheelchairs passing spaces within a sidewalk corridor. Passing spaces shall be 5 feet x 5 feet minimum, and no farther apart than 200 feet. Driveway crossings and curb ramps with level landings can also serve as passing spaces. If a sidewalk is less than 60" wide, then accommodations must be made for passing space areas to be provided. In areas with frequent driveway crossings, the driveway surface can serve to accommodate passing space at the point where the driveway intersects the sidewalk.

The ADA self-assessment reviewed the measured sidewalk widths along a sample of 95.7 miles of sidewalk within the City (9.7% sample) using high resolution 2020 aerial photography. Within that sample there were 7.9 miles of sidewalk narrower than 60" which might be candidates for having more than 200 feet of insufficient passing space.

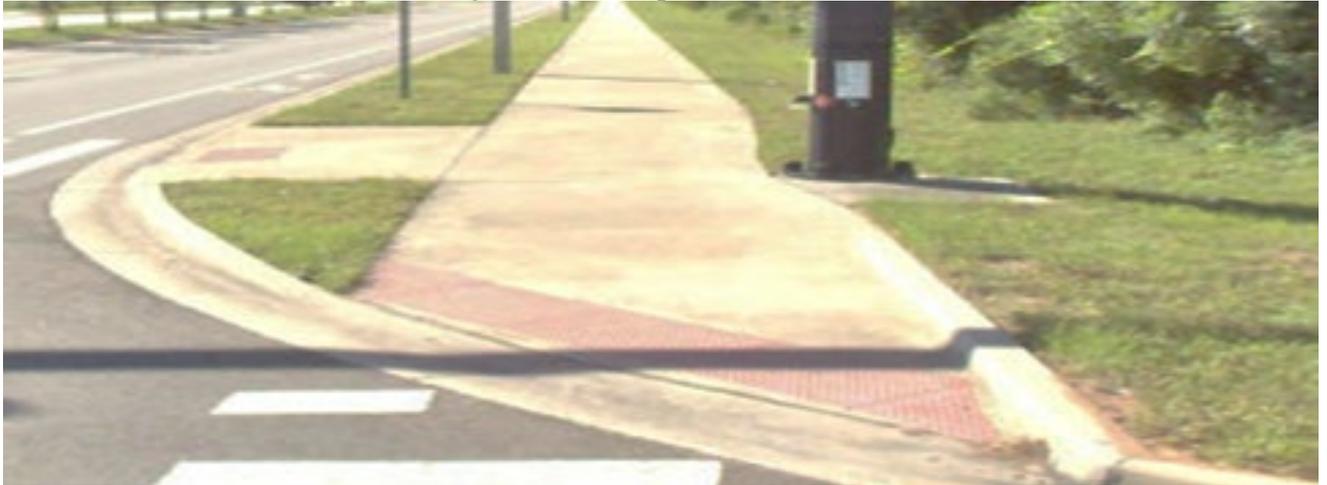
A curb ramp is a short incline cutting through a curb or built up to it. If designed and constructed to be accessible, a curb ramp provides an accessible route that people with disabilities can use to safely transition from a roadway to a curbed sidewalk and vice versa. Curb ramps are critical to providing access between the sidewalk and the street for people who use wheelchairs. They are most commonly found at intersections, but they may also be used at other locations such as on-street parking, loading zones, bus stops, and midblock crossings.

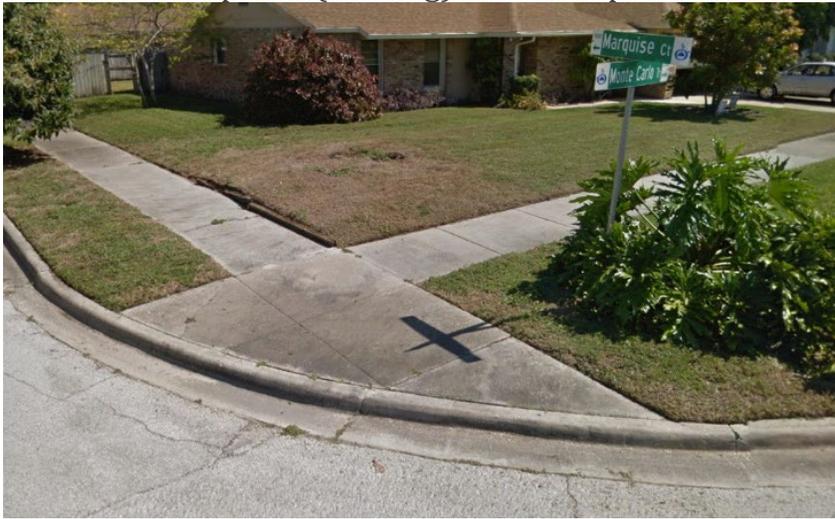
#### 4.2.1 Non-Compliant (Missing) Curb Ramps

A curb ramp or blended transition shall be provided wherever a public sidewalk or pedestrian route crosses a curb or other change in level, including at intersections, midblock crosswalks, medians and islands traversed by crosswalks, alleys, accessible parking aisles, passenger loading zones; and locations where the public sidewalk ends, and pedestrian travel continues in the roadway. If a pedestrian access route leads a pedestrian up to a curb with no accommodation for traversing the curb into the roadway, then that curb ramp is considered to be non-compliant or missing.

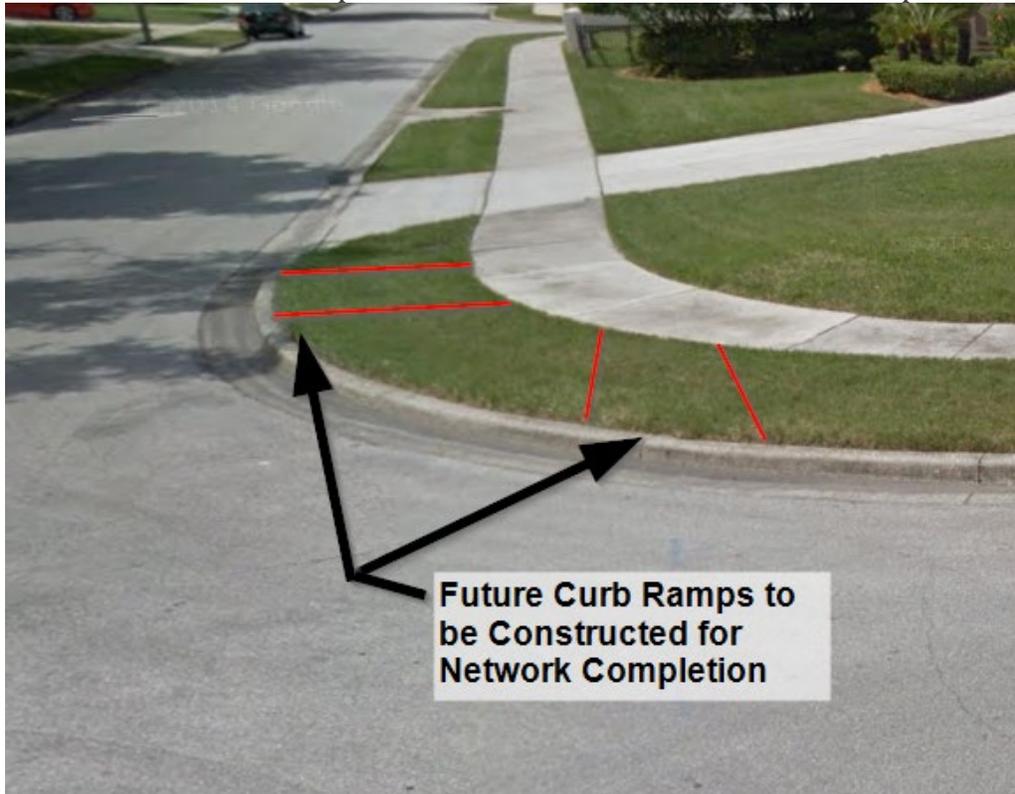
#### 4.2.2 Future Curb Ramps to be Constructed for Network Completion

Ramps whose construction would provide an additional connection in the pedestrian access route were considered to be Future Curb Ramps to be Constructed for Network Completion.

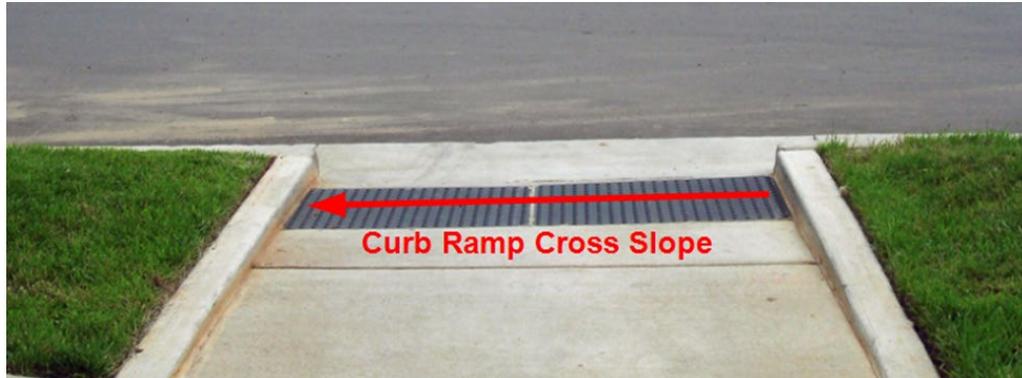
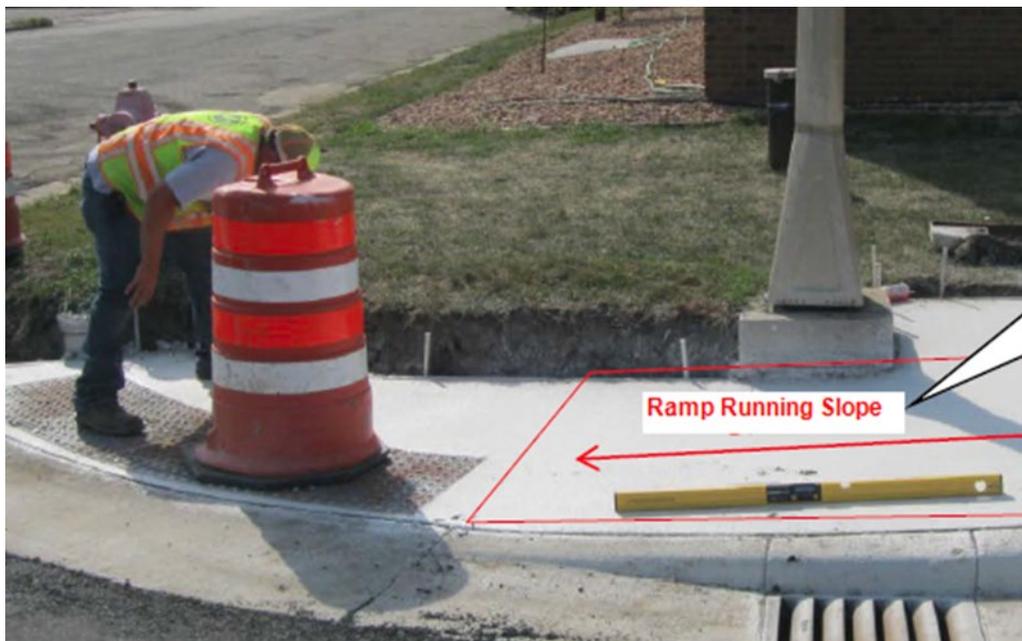
The curb ramp cross slope is measured across the width of the ramp while the curb ramp running slope is measured along the length of the ramp as shown in the images below:

The PROWAG Guidelines Sections R304.2 – R304.4 specify a maximum allowable running slope of 8.3% and a minimum allowable running slope of 5% for compliant curb ramps. Section R304.5 of the same Guidelines specifies a maximum allowable cross slope of 2%.

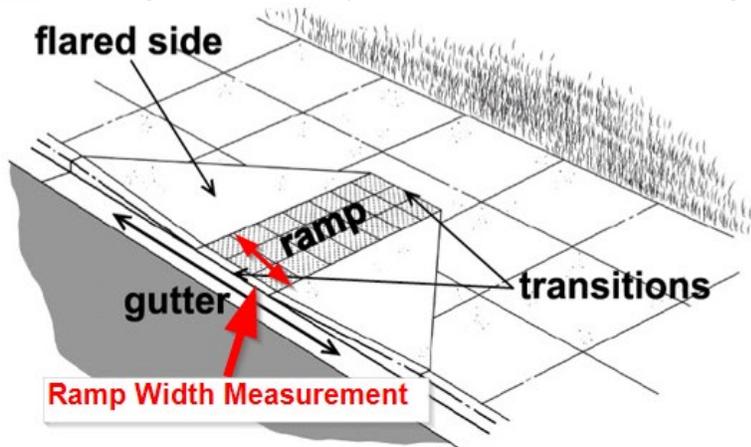
The curb ramp width is measured across the width of the ramp surface that the wheelchair is traveling down, **not** including the width of any side flares as shown in the image below:

The PROWAG Guidelines Section R304.5 specifies a minimum allowable ramp width of 4.0 feet (48"). Recognizing that the curb ramp can be a bottleneck to pedestrian flow, the minimum clear width of four feet matches the minimum 48-inch width of the pedestrian access route in several areas where exceptions to the 60-inch width are permitted. Wheelchair bases have gotten wider in recent years and three-wheeled scooter use has become more prevalent. In addition, the wider curb ramp widths allow for some wheelchair maneuvering on the curb ramp to adjust for approaching curb ramp bottoms that are skewed.

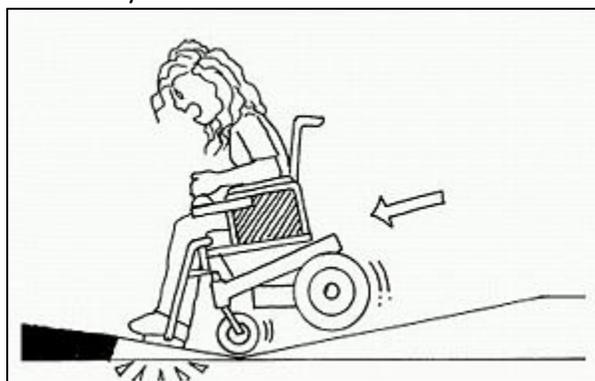
Gutter counter slope is the angle point or grade change where the down slope of the curb ramp meets the up cross slope of the gutter. It is the reverse slope that the pedestrian encounters at the bottom of the curb and gutter to travel back towards the roadway.

Steep counter slopes will cause some wheelchairs to catch on back rollers and lose drive wheel traction. For others, the steep counter slope will catch footrests.

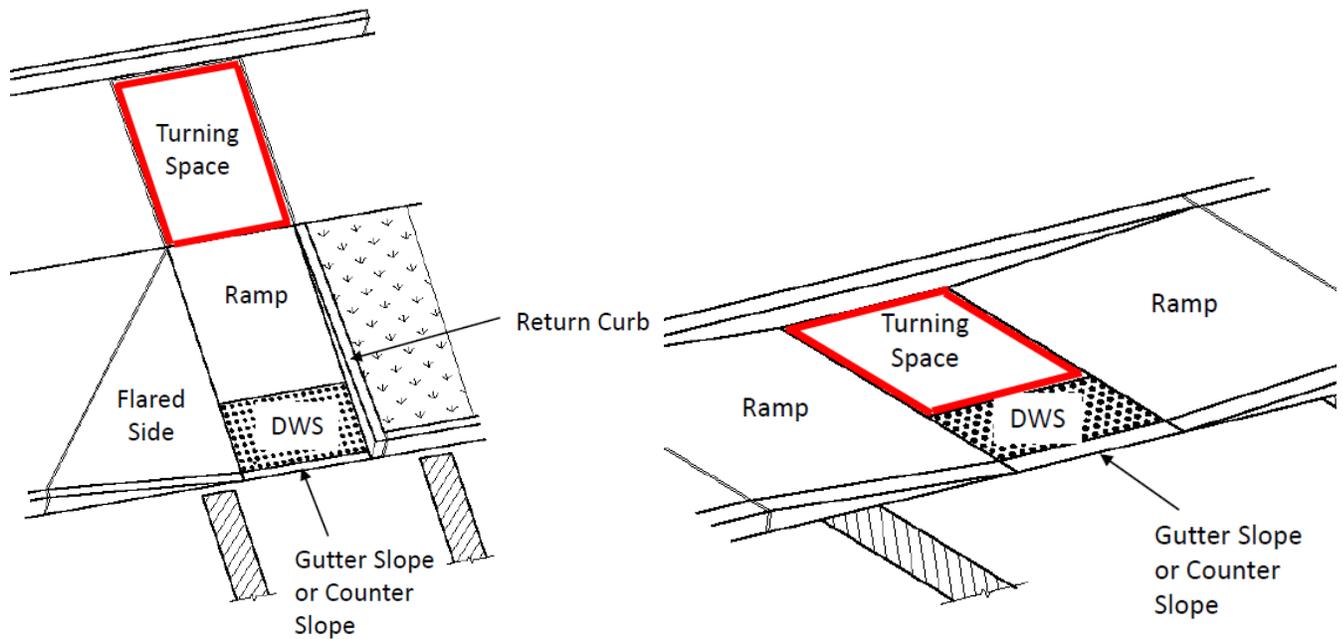
Whenever a ramp requires a pedestrian to make a turn, either at the top or bottom of the ramp, there must be a clear space available on a level surface to make the turn. Examples of level turning spaces on perpendicular and parallel curb ramps are provided in the illustrations below.

The PROWAG Guidelines Section R304.2.1 specifies that Landings providing turning space, including flush landings, shall have a minimum clear dimension of a 60-inch by 60-inch (1525 by 1525mm) square or 60-inch diameter circle. Landings may overlap with adjacent landings, or a single landing may serve multiple curb ramps or transition ramps. Landings may overlap with the clear ground or floor space required at push buttons.

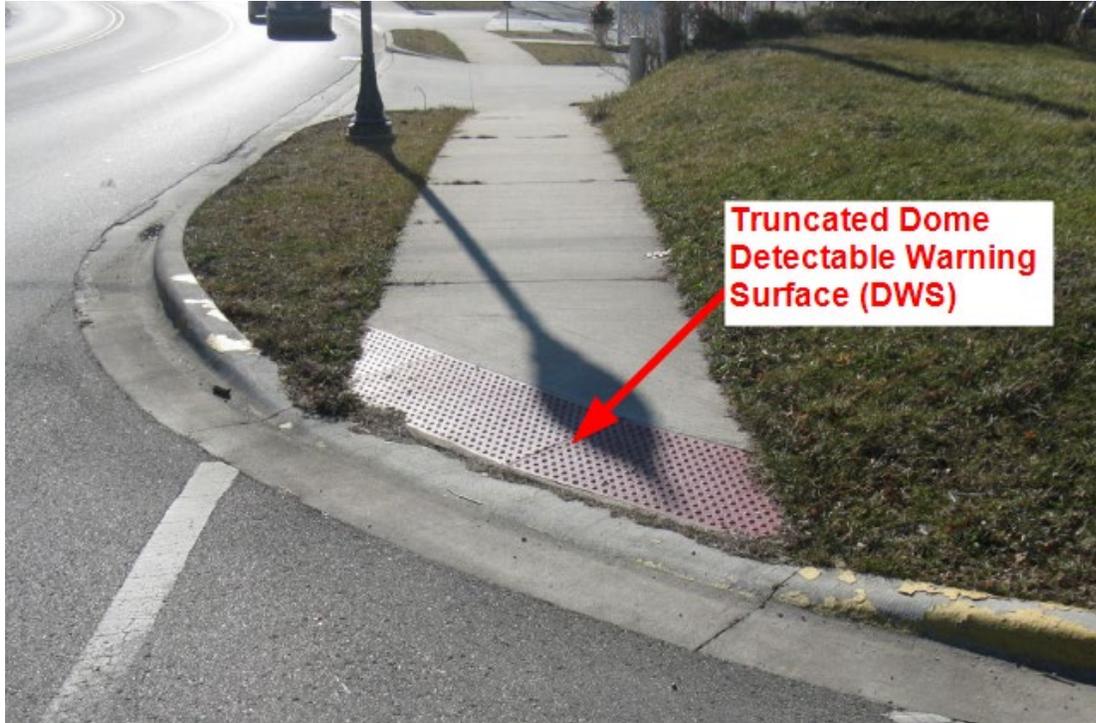
Detectable warnings are used, in the absence of a curb, to provide an 'edge cue' for people who are blind or have low vision at the junction of a pedestrian access route (i.e. sidewalk, etc.) and a vehicular way (i.e., street, roadway, etc.)

Detectable warnings are a distinctive surface pattern of truncated domes detectable by cane or underfoot that alert people with vision impairments of their approach to street crossings and hazardous drop-offs. They are used to indicate the boundary between pedestrian and vehicular routes where there is a flush connection instead of a curbed connection. The truncated domes are aligned on a square grid in the direction of pedestrian travel or installed radial to the grade break. Detectable warnings are not stamped into concrete. Detectable warnings contrast visually with the adjoining surface, either light-on-dark or dark-on-light (recommended bright red on concrete and bright yellow on asphalt).

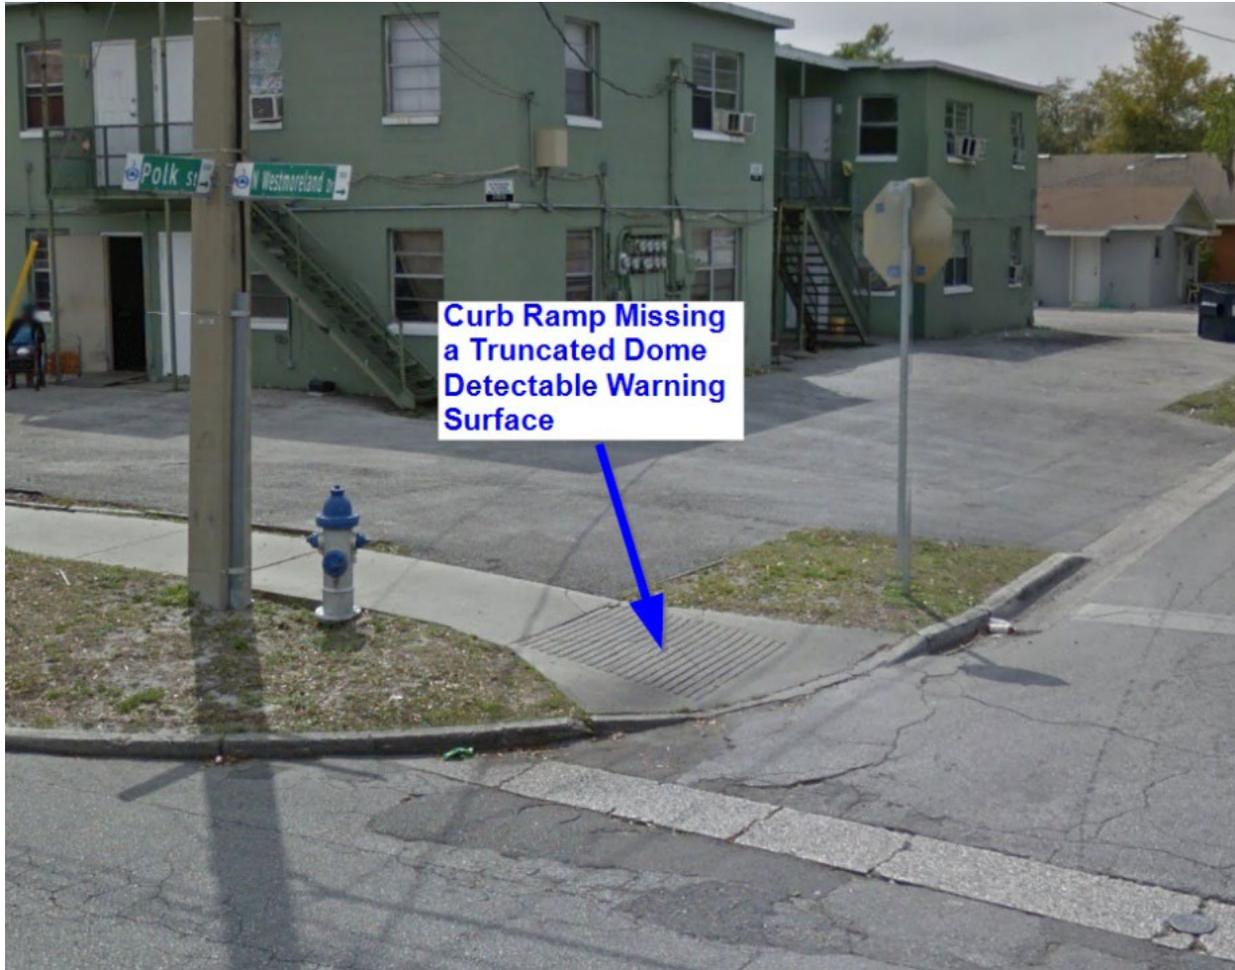
The ADA self-assessment reviewed the entire sidewalk network totaling 983 miles of sidewalk within the City (100% sample) using high resolution 2020 aerial photography and identified a total of 16,779 curb ramps that either currently existed or were under construction. A review of those curb ramps identified 6,877 curb ramps citywide where the curb ramp did not have a high contrast detectable warning surface consisting of truncated domes. For these ramps, curb ramp modification consisting of the installation of truncated dome detectable warning surfaces would be necessary to provide a compliant connection between the pedestrian access route and the roadway crossing. At the time of alteration to add the truncated dome detectable warning surface, the City will also be required to verify that all other aspects of the ramp are compliant with ADA and PROWAG guidelines. The complete listing of the identified 6,877 existing curb ramps lacking truncated dome detectable warning surfaces citywide is provided in this report as Appendix K.

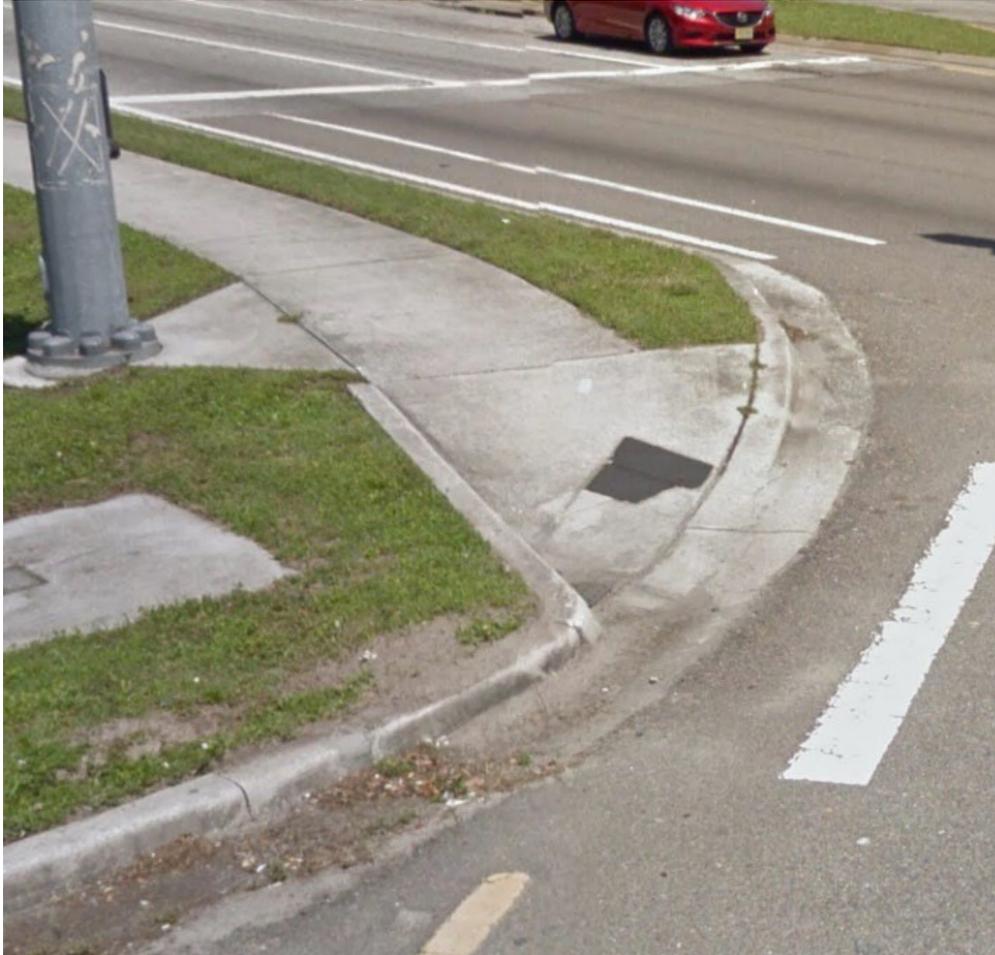
#### 4.2.8 Existing Curb Ramps Where Detectable Warning Surfaces Lack Full Coverage

Detectable warning surfaces indicate the boundary between a pedestrian route and a vehicular route where there is a flush rather than a curbed connection for pedestrians who are blind or have low vision. The truncated domes provide tactile feedback, while the high color contrast between the warning surface and the sidewalk are intended to provide visual feedback. For this reason, it is important that the detectable warning surface cover the full width of the ramp so that the pedestrian is guaranteed to encounter the surface before traveling into the roadway.

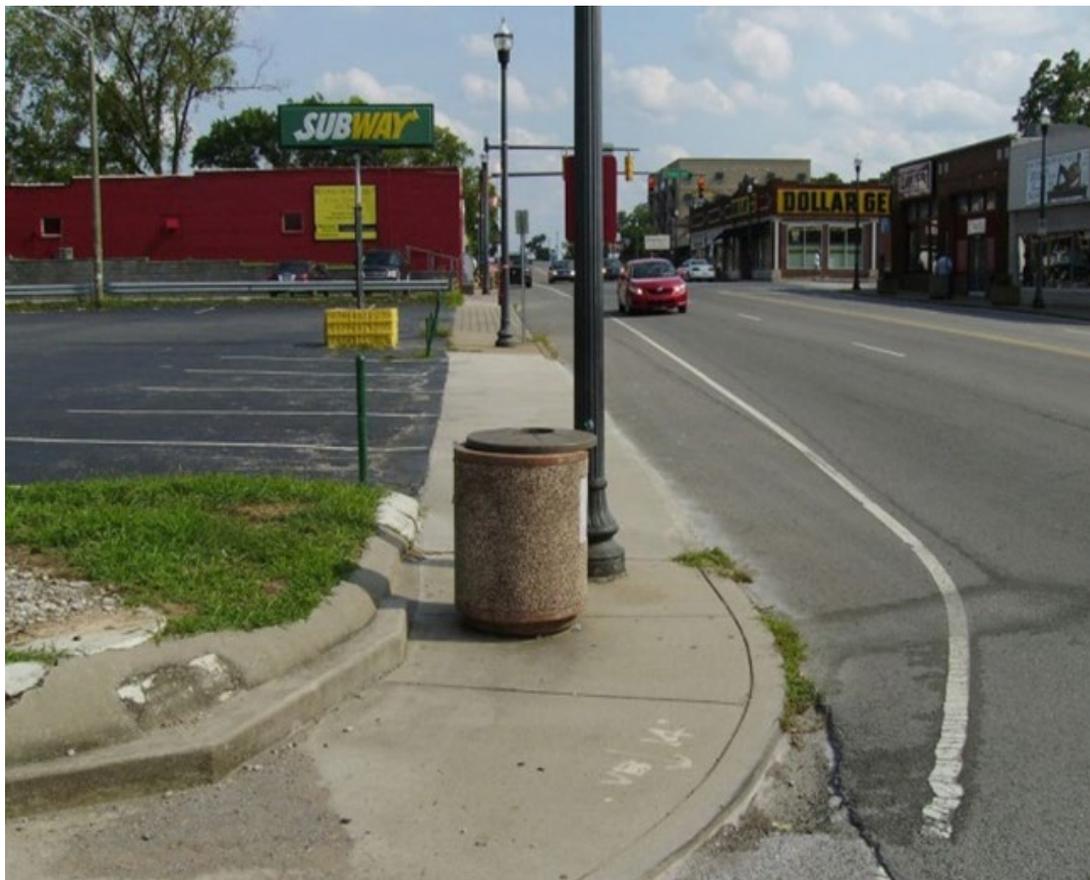
### 4.3 Sidewalk Obstacles

Obstacles in the pedestrian environment are defined as objects that limit the vertical passage space, protrude into the circulation route, or reduce the clearance width of the sidewalk. Obstacles with large overhangs that protrude into the path of travel can be hazardous for people with visual impairments if they are difficult to detect. The full width of the circulation path should be free of protruding objects. Obstacles that reduce the minimum clearance width, such as decorative planters on a narrow sidewalk, can create significant barriers for wheelchair or walker users.

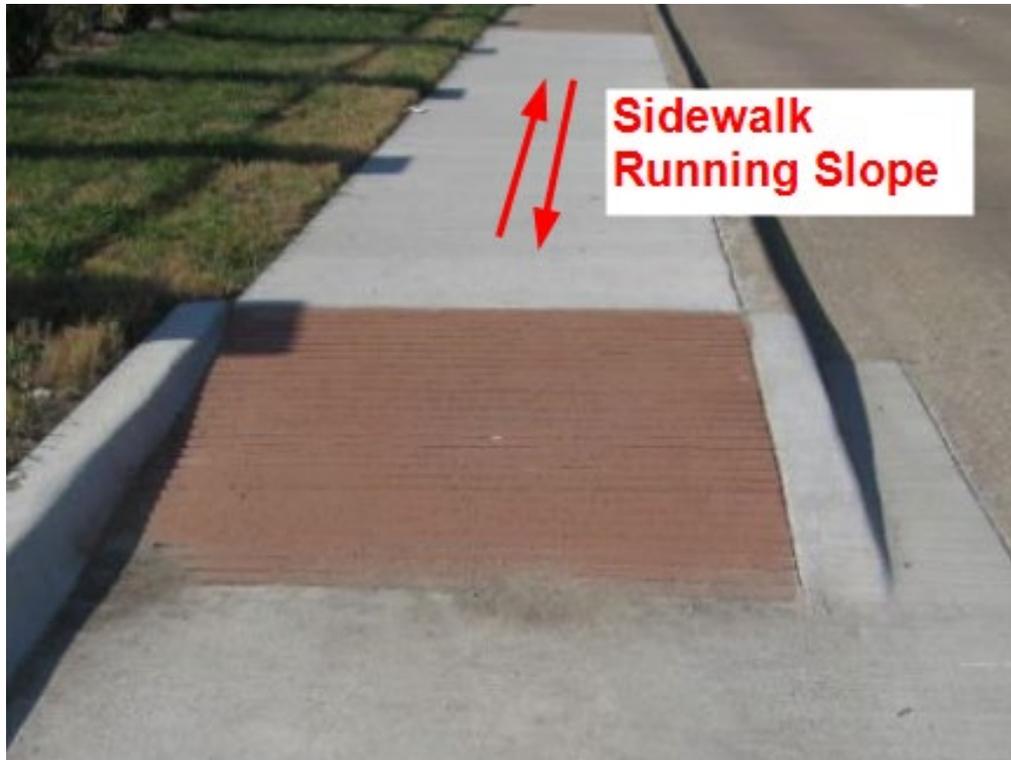
pedestrians who are blind or have low vision. The PROWAG Guidelines Section R302.5 addresses hazards associated with sidewalk grade. Grade is the running slope parallel to the direction of pedestrian travel. Grade is calculated by dividing the vertical change in elevation by the horizontal distance covered and is expressed as a percent.

Where pedestrian access routes are contained within a street or highway right-of-way, the grade of the pedestrian access route is permitted to equal the general grade established for the adjacent street or highway, except that where pedestrian access routes are contained within pedestrian street crossings a maximum grade of 5 percent is required. This is consistent with the AASHTO "Policy on Geometric Design of Highways and Streets" which recommends that the sidewalk grade follow the grade of adjacent roadways, and also recommends maximum cross slopes for roadways. Where pedestrian access routes are not contained within a street or highway right-of-way, a maximum grade of 5 percent is required.

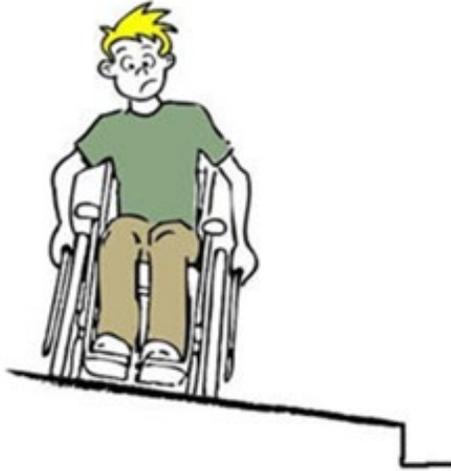
The PROWAG Guidelines Section R302.6 addresses hazards associated with sidewalk cross slope. Cross slope is the slope perpendicular to the direction of pedestrian travel. On a sidewalk, cross slope is measured perpendicular to the curb line or edge of the street or highway. Cross slope impedes travel by pedestrians who use wheeled mobility devices since energy must be expended to counteract the perpendicular force of the cross slope. Cross slope makes it more difficult for pedestrians who use wheelchairs to travel on uphill slopes and to maintain balance and control on downhill slopes. Cross slope also negatively affects pedestrians who use braces, lower limb prostheses, crutches, or walkers, as well as pedestrians who have gait, balance, or stamina impairments.

A maximum cross slope of 2 percent is specified for pedestrian access routes, except for pedestrian access routes contained within certain pedestrian street crossings in order to allow for typical roadway geometry. A 5 percent maximum cross slope is specified for pedestrian access routes contained within pedestrian street crossings without yield or stop control to avoid any unintended negative impacts on the control and safety of vehicles, their occupants, and pedestrians in the vicinity of the intersection. (Pedestrian street crossings without yield or stop control are crossings where there is no yield or stop sign, or where there is a traffic signal that is designed for the green phase.) At pedestrian street crossings without yield or stop control vehicles can proceed through the intersection without slowing or stopping. The cross slope of pedestrian access routes contained within midblock pedestrian street crossings is permitted to equal the street or highway grade.

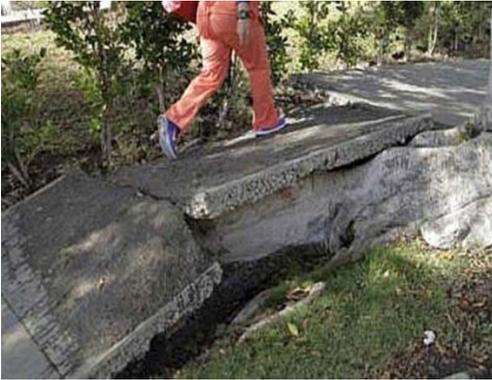
Sidewalks are prone to “Damage” caused by environmental conditions. Maintaining sidewalk elements in good condition is an essential part of providing access to public rights-of-way. Sidewalks in poor repair can limit access and threaten the health and safety of pedestrians. If sidewalks are in poor condition or nonexistent, pedestrians are forced to travel in the street.

Examples of sidewalk damage may include trip edges, heaving and settlement due to vegetation uplift and shattering due to excessive loading. Damage is typically considered to be vertical discontinuities of 0.25 in or greater at any point on the walkway that could cause pedestrians to trip, lock up the wheels of a wheelchair, or prevent the wheels of a wheelchair from rolling smoothly.

The presence of trip edges and vertical surface discontinuities result in an uneven surface which may be hazardous for a visually impaired pedestrian, or difficult to traverse for a pedestrian in a wheelchair. This barrier may be mitigated by grinding down the trip edge or removing and replacing an affected section of sidewalk. The PROWAG Guidelines Section R302.7.2 addresses the subject of vertical surface discontinuities. The allowance for vertical surface discontinuities is for occasional expansion joints and objects such as utility covers, vault frames, and gratings that cannot be located in another portion of the sidewalk outside the pedestrian access route. However, objects such as utility covers, vault frames, and gratings should not be located on curb ramp runs, blended transitions, turning spaces, or gutter areas within the pedestrian access route. This may not always be possible in alterations but should be avoided wherever possible. Vertical surface discontinuities between unit pavers should be minimized.

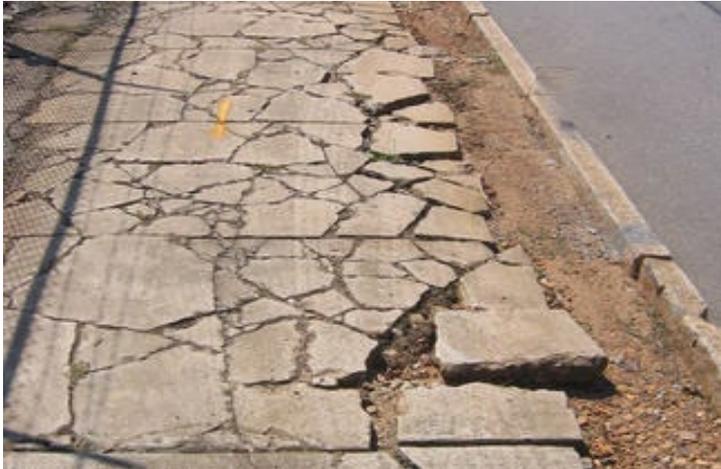
Separate from trip edges, other sidewalk damage might include corner breaks, heaving, settlement, and shattering. These barriers result in an uneven surface which may be hazardous for a visually impaired pedestrian, or difficult to traverse for a pedestrian in a wheelchair. Typically, this other sidewalk damage is mitigated by removing and replacing an affected section of sidewalk.

The PROWAG Guidelines Section R302.7.1 addresses the subject of vertical alignment and surfaces. Pedestrian access route surfaces must be generally planar and smooth. Surfaces should be chosen for easy rollability. Surfaces that are heavily textured, rough, or chamfered and paving systems consisting of individual units that cannot be laid in plane will greatly increase rolling resistance and subject pedestrians who use wheelchairs, scooters, and rolling walkers to the stressful and often painful effects of vibration.

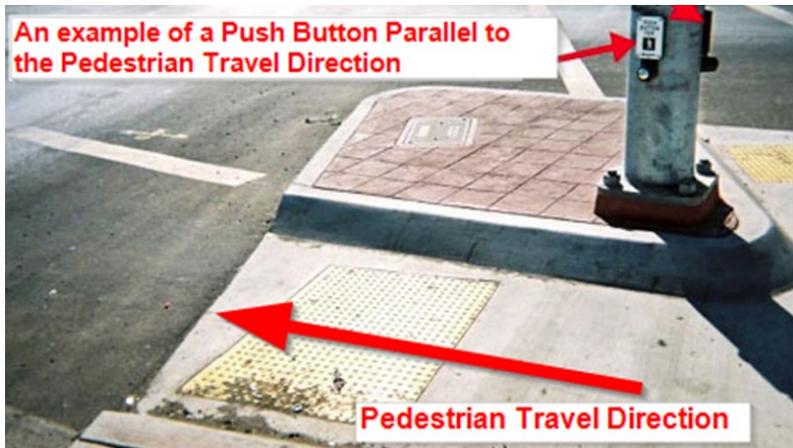
Pedestrian Signal Buttons and Informational Signs should be mounted in such a manner so that the face of the push button is parallel to the direction of crossing. This provides a clear indication to the pedestrian as to determine which detector button corresponds to the curb ramp and cross walk.

For example, if two crosswalks, oriented in different directions, end at or near the same location, the positioning of pedestrian detectors and/or the legends on the pedestrian detector signs should clearly indicate which crosswalk signal is actuated by each pedestrian detector and the button placement and sign orientation should be clearly placed parallel to the direction of the ramp crossing.

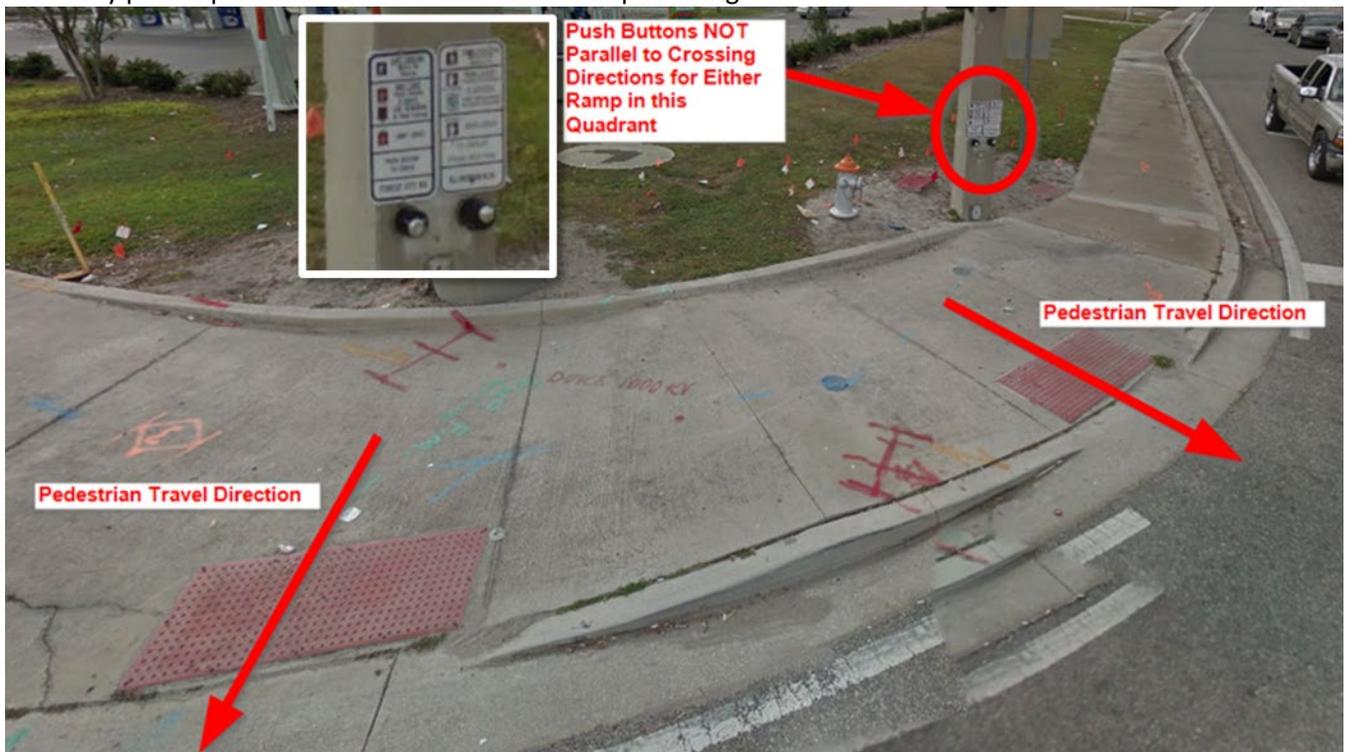
While the PROWAG Guidelines do not address pedestrian detector pushbutton orientation directly, the Guidelines incorporate the MUTCD Section 4E by reference, the 2009 Edition of the MUTCD Section 4E.08.04F calls for a pedestrian detector pushbutton orientation with "the face of the pushbutton parallel to the crosswalk to be used;"

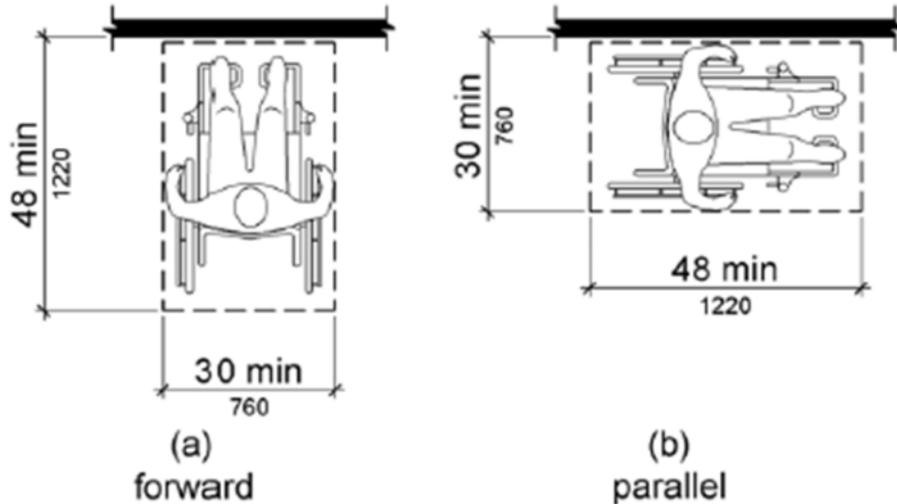
The PROWAG Guidelines Section R404 state that clear spaces are required at operable parts including accessible pedestrian signals and pedestrian pushbuttons and parking meters and parking pay stations that serve accessible parking spaces. Clear spaces are also required at benches and within transit shelters. Clear spaces must be 30" (2.5 feet) minimum by 48" (4 feet) minimum. Additional maneuvering space must be provided where an element is confined on all or part of three sides. The running slope of clear spaces is permitted to be consistent with the grade of the adjacent pedestrian access route. This requirement differs from the 2004 ADA and ABA Accessibility Guidelines which does not permit slopes steeper than 2 percent at clear spaces. A 2 percent maximum cross slope is specified for clear spaces.

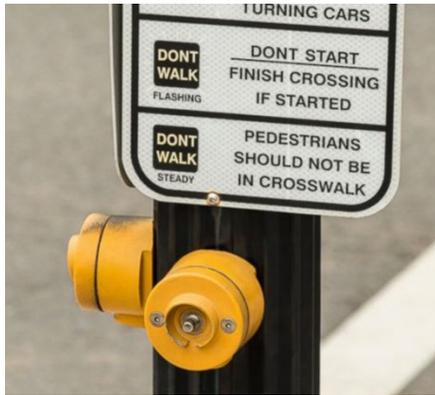
Some individuals may have difficulty operating pedestrian push buttons. In some instances, there may be a need to install a larger push button to accommodate certain extremity disabilities. For example, the pushbutton in the image below contains a small, recessed pushbutton which does not meet current standards. The U.S. Access Board Guidelines Section X02.5.1.2(A) states that Push buttons shall be a minimum of 2 inches across in at least one dimension. Section X02.5.1.2(C) states that push buttons shall be operable with a closed fist.

As part of the ADA self-assessment, a detailed field inspection was performed at 55 signalized intersections out of the 548 City maintained signalized intersections citywide resulting in a 10% sample for the self-assessment. At the 55 sampled intersections there were a total of 54 pedestrian signal detector push buttons that did not have the required diameter of 2” and operable by a closed fist. For these pedestrian detector pushbuttons, the detector pushbutton unit would need to be replaced to be consistent with the guidelines. The complete set of inspection reports for the 55 sampled intersections comprising the 10% sample is provided in this report as Appendix H.

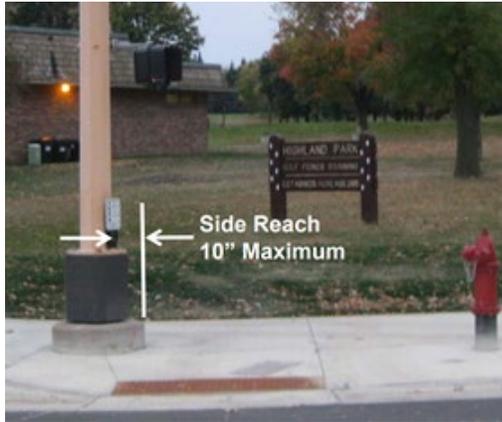
Because of ground obstructions, a wheelchair may not be able to be positioned directly adjacent to a pushbutton. There may be landscaping, pole foundations or other obstructions that require the disabled pedestrian to reach beyond the envelope of the wheelchair.

The PROWAG Guidelines state that side reach over an obstruction is permitted where the depth of the obstruction between the clear space and the element is a maximum of 10 inches.

At the 55 sampled intersections there were a total of 99 pedestrian signal detector push buttons that had a required button side reach greater than 10 inches. For these pedestrian detector pushbuttons, the detector pushbutton unit would need to be removed and relocated to a location that is consistent with the guidelines. The complete set of inspection reports for the 55 sampled intersections comprising the 10% sample is provided in this report as Appendix H.

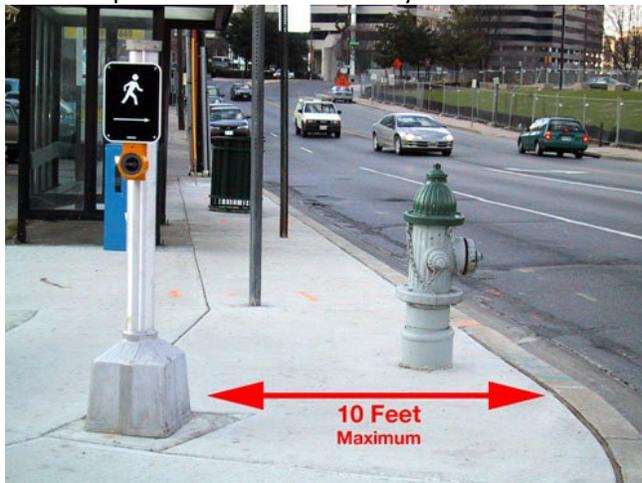
While the PROWAG Guidelines do not specifically address this issue, the U.S. Access Board Guidelines Section X02.5.1.3E states that the push button shall be mounted no further than 5 feet from the extension of the crosswalk lines, and within 10 feet of the curb line, unless the curb ramp is longer than 10 feet.

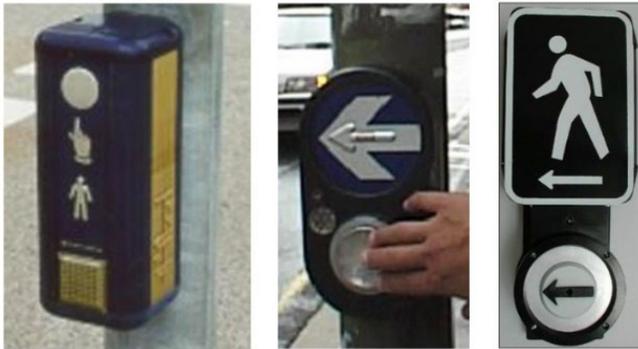
The pedestrian pushbutton has a locator tone for detecting the device and a tactile arrow to indicate which pedestrian street crossing is served by the device. The MUTCD contains standards for accessible pedestrian signals and pedestrian pushbuttons but does not require that they be provided. The proposed guidelines require accessible pedestrian signals and pedestrian pushbuttons to be provided when new pedestrian signals are installed. For existing pedestrian signals, the proposed PROWAG guidelines require accessible pedestrian signals and pedestrian pushbuttons to be provided when the signal controller and software are altered, or the signal head is replaced. Accessible pedestrian signals and pedestrian pushbuttons must comply with the referenced standards in the MUTCD and Section R209 of the PROWAG Guidelines.

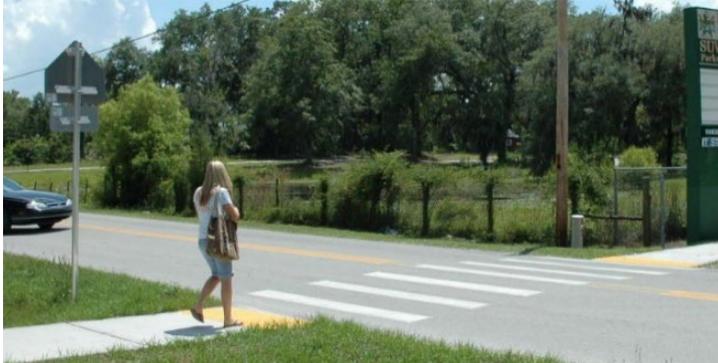
Crosswalks are locations where the pedestrian access route intersects the roadway or other surface where vehicular traffic is expected. They may be marked or unmarked and may exist at intersections that are controlled by signalization or signage or are uncontrolled. Crosswalks constitute distinct elements of the right-of-way intended to facilitate pedestrian traffic across the roadway. A marked crosswalk can benefit pedestrians by directing them to cross at locations where appropriate traffic control, including traffic signals either currently exist or can be provided. However, marked pedestrian crosswalks, in and of themselves, do not slow traffic or reduce pedestrian crashes.

The PROWAG Guidelines do not specifically address where crosswalks are required, however, where crosswalks have been marked, PROWAG Section R302 specifies guidelines for the crosswalks.

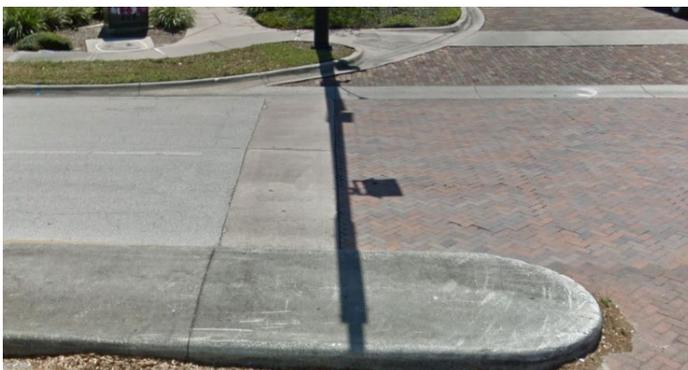
For these crosswalks, the standard crosswalk pavement markings should be added to the intersections to be consistent with the current City Engineering Standards Manual.

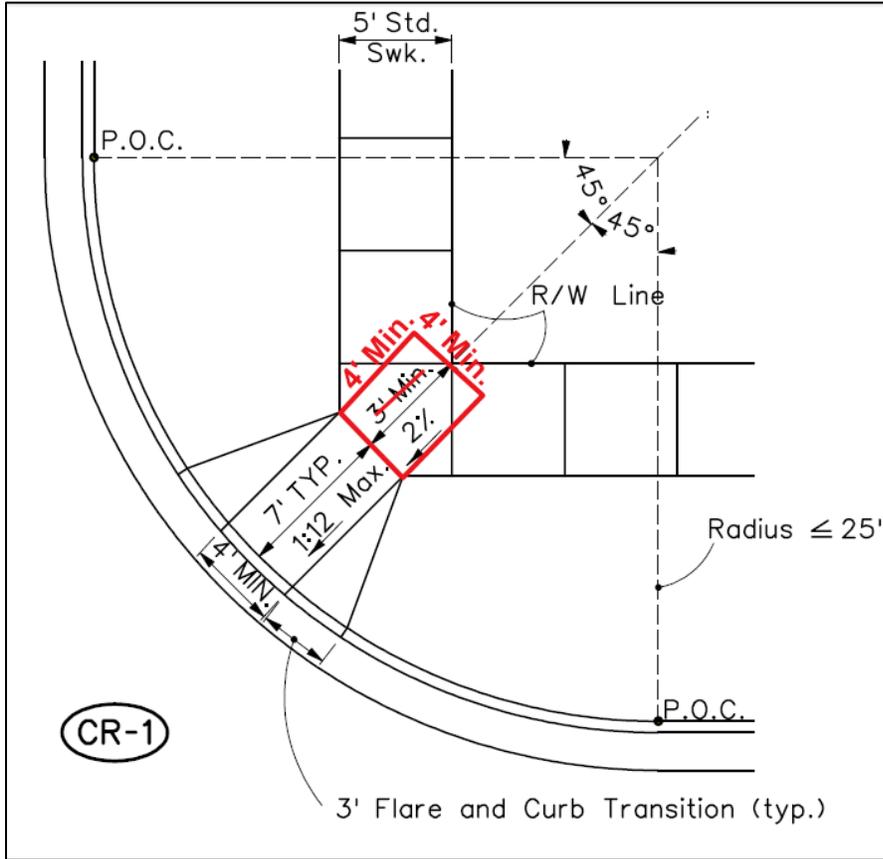
The City should also consider removing this ramp example representing a shared diagonal ramp for both pedestrian travel directions. The U.S. Access Board states: “do not use this (diagonal ramp) design unless constraints require it, paired ramps are always preferred”. PROWAG R207 states that “typically two curb ramps must be provided at existing street corners”, “unless physical constraints prevent two curb ramps from being installed”. The single shared diagonal ramp provides no direction guidance for the visually impaired pedestrian and the single shared landing eliminates the ability to separate the APS push buttons on two poles. Referencing Guideline: Turning Space As specified in PROWAG Sections R304.5.1
